**ROHNER CREEK FLOOD CONTROL, SEISMIC AND  
HABITAT IMPROVEMENT PROJECT**

**Addendum No. 2**

City of Fortuna  
Rohner Creek Flood Control, Seismic and Habitat  
Improvements Project  
Bridge and Miscellaneous Structures Limited Hazardous  
Material Assessment Survey Report

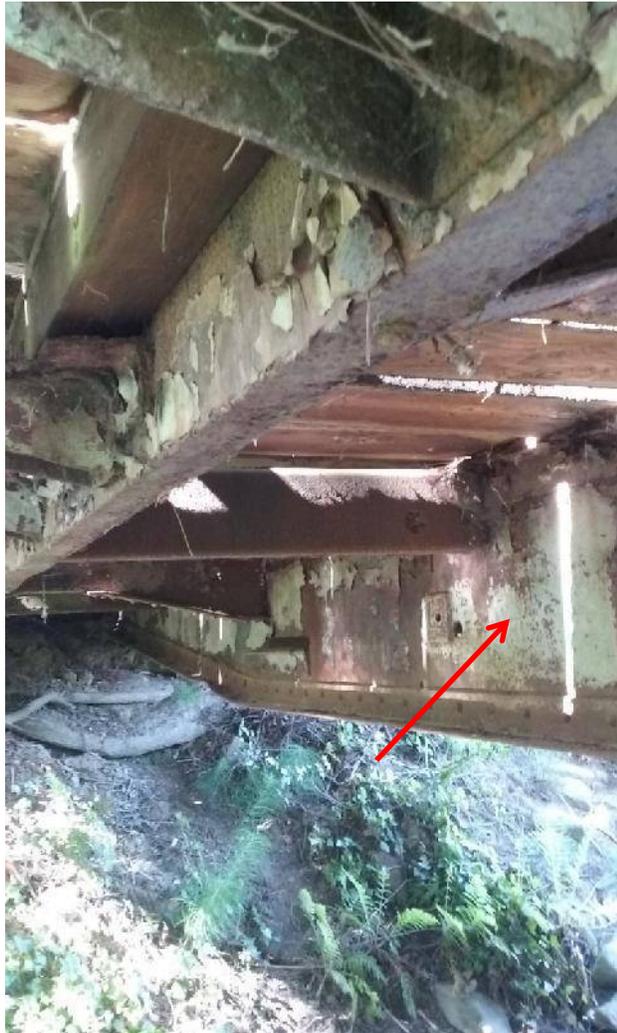
Photograph 1 – Paint (typical, indicated by red arrow) reported to contain asbestos located at existing bridge at STA 9+25.

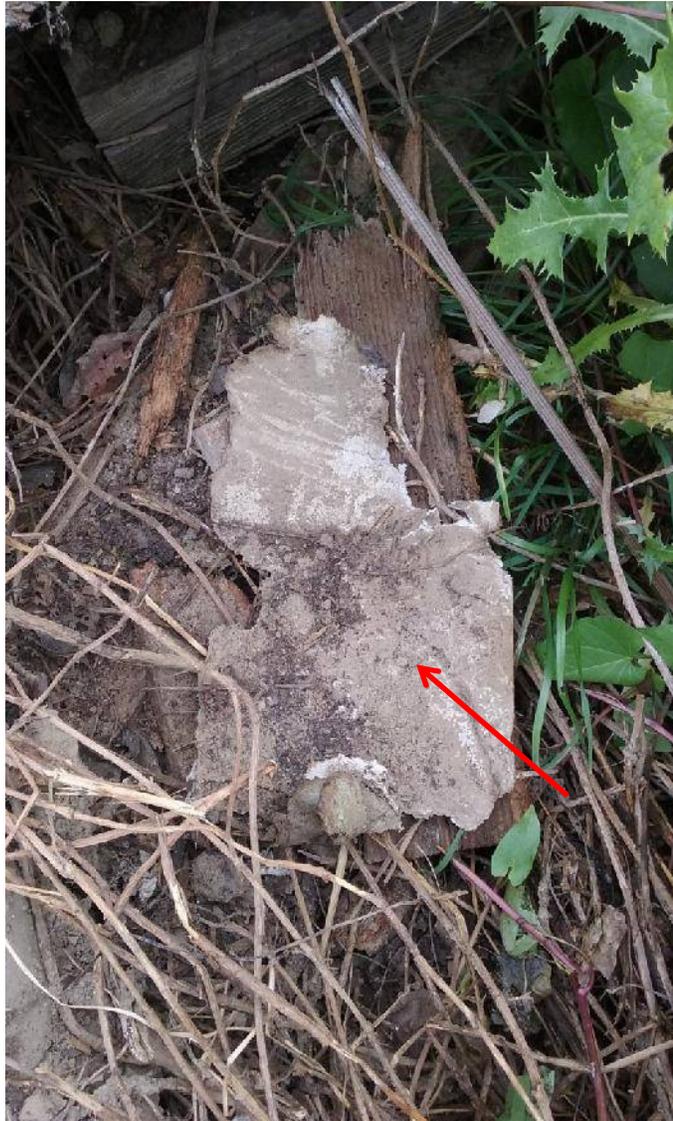
Photograph 2 – Fibrous sheeting remnant (typical, indicated by red arrow) reported to contain asbestos located at outbuilding debris pile at STA 20+40.

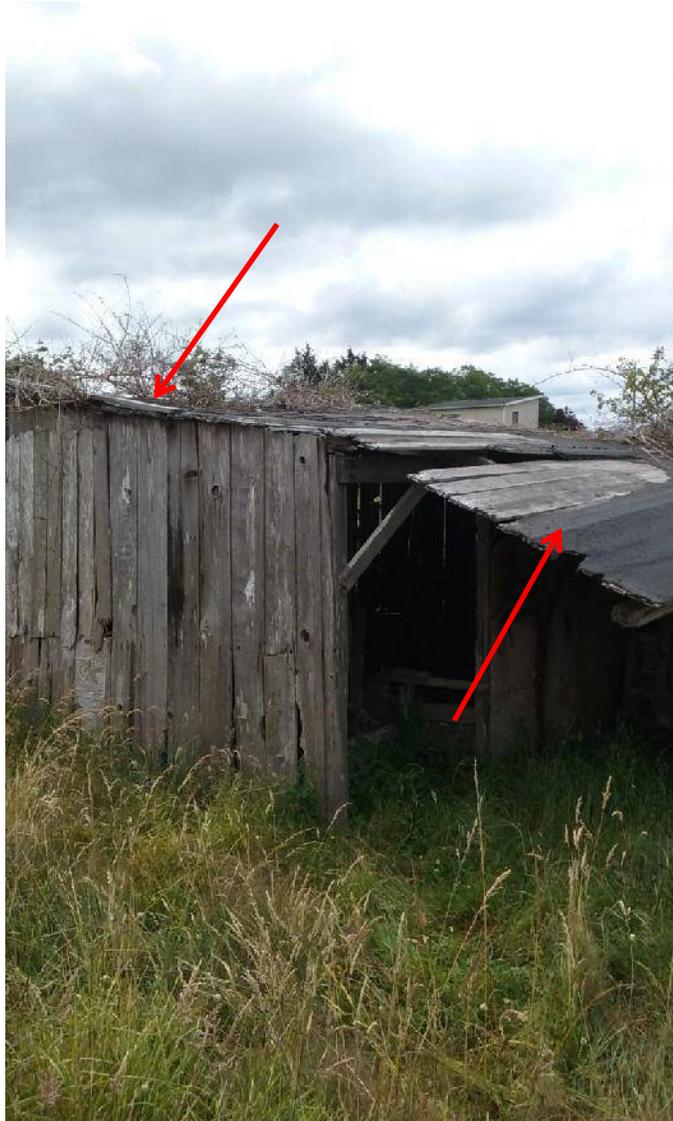
8411414-40	Bituminous (tar) roofing felt (black)	Outbuilding north of swale at S–3+00 (northwest shed) – Roof	15% Chrysotile	Included with Above Quantity	Category I Nonfriable ACM	Class II	Non- Hazardous Asbestos Waste

Photograph 3 – Roofing material (typical, indicated by red arrows) reported to contain asbestos located at outbuilding north of swale at S-3+00.

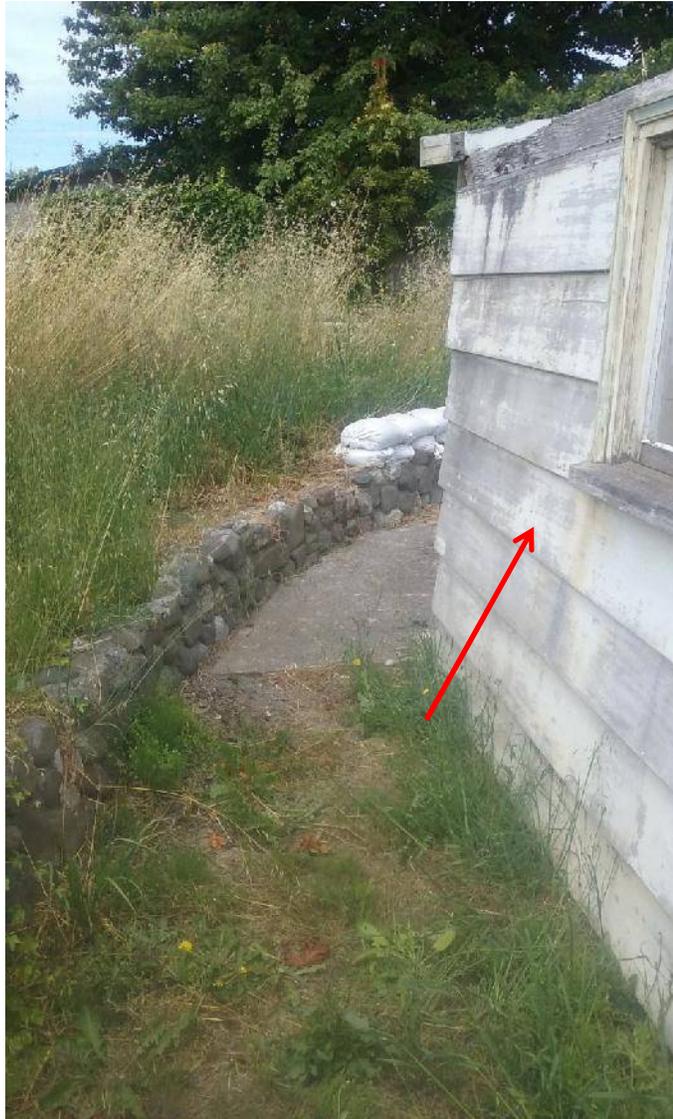
Photograph 4 – Location of skim coat (typical, indicated by red arrow) reported to contain asbestos located at garage addition at STA 14+25.
