**ROHNER CREEK FLOOD CONTROL, SEISMIC AND  
HABITAT IMPROVEMENT PROJECT**

**Addendum No. 2**

City of Fortuna  
Rohner Creek Flood Control, Seismic and Habitat  
Improvements Project  
Bridge and Miscellaneous Structures Limited Hazardous  
Material Assessment Survey Report

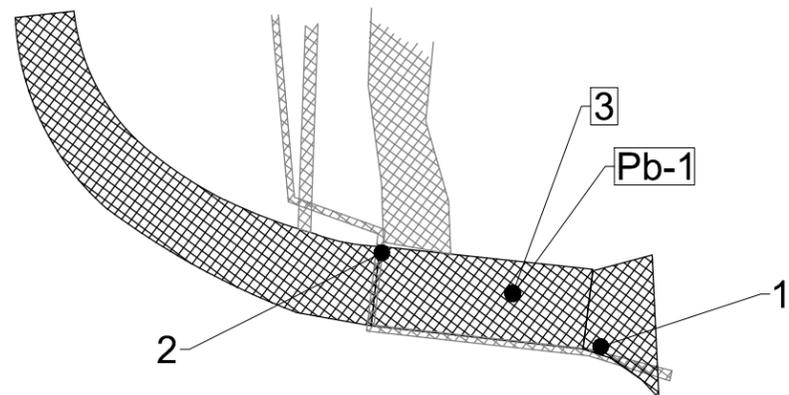
**1** BRIDGE @ STA 9+25 (600 STILLMAN WAY)  
 NTS

Photograph 1 – Paint (typical, indicated by red arrow) reported to contain asbestos located at existing bridge at STA 9+25.
